Crack Growth Behaviour of Spur Gears:  
A Fractographic Analysis

DSTO-TN-0137

Airframes and Engines Division  
Aeronautical and Maritime Research Laboratory

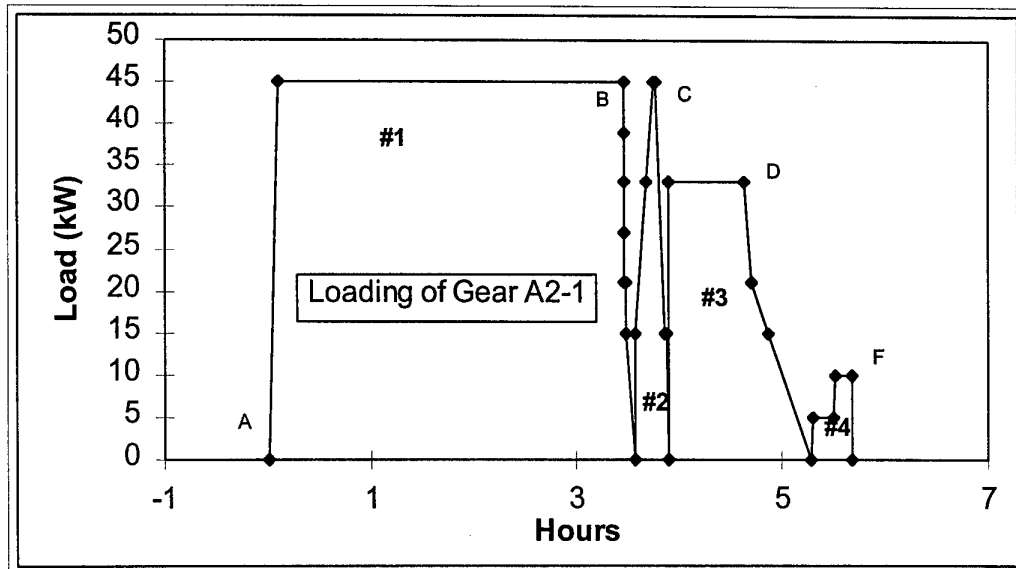
Figure 4.1 Loading sequence of Gear A2-1

The loading sequence for this gear consisted of four runs as can be seen in Figure 4.1. The rig was run at the maximum load of 45kW for the entire first run. After approximately 3.5 hours the monitoring system showed the kurtosis to increase to a value of 3.25, at which point the rig was shut down. In the second run, the kurtosis jumped quite significantly when the load reached 39kW. Hence when it was further increased to 45kW the increase of kurtosis to approximately 4.2 resulted in an immediate unloading sequence and end of the run. Lower loads were applied in the third run to produce a more gradual propagation of the crack and to minimise any discrepancies between the kurtosis indices and the actual condition of the cracked tooth. Hence the load was left at 33kW and after 45 minutes the unloading sequence began. In the final run, the load was started at a conservative level of 5kW since the crack had already progressed by an extensive amount (as indicated by the MRI results, see Section 6). The rig was shut down at a loading of 10kW.

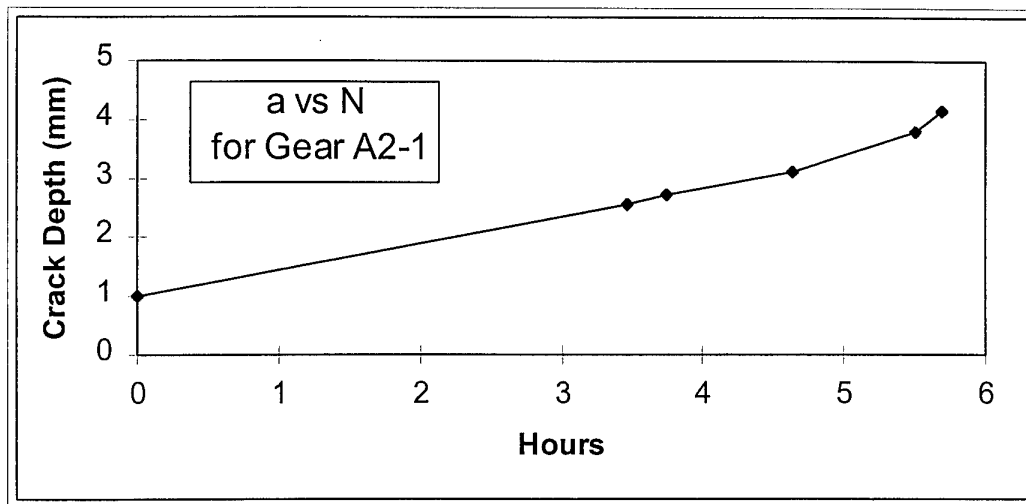
Figure 10.2 Crack growth curve for Gear A2-1

The final two marks were ones that were observed using different lighting conditions and higher magnification. Mark D is a mark that can be clearly seen on the boundary but not very well on the inner surface. It corresponds to the end of run number 3. Finally, mark E is a small mark corresponding to the last run when the load is incremented from 5kW to 10kW. The crack depth versus time curve resulting from this, can be seen in Figure 10.2. The general trend of crack depth increasing with time can be seen quite clearly. The corresponding log-linear curve is shown in Figure 10.3.

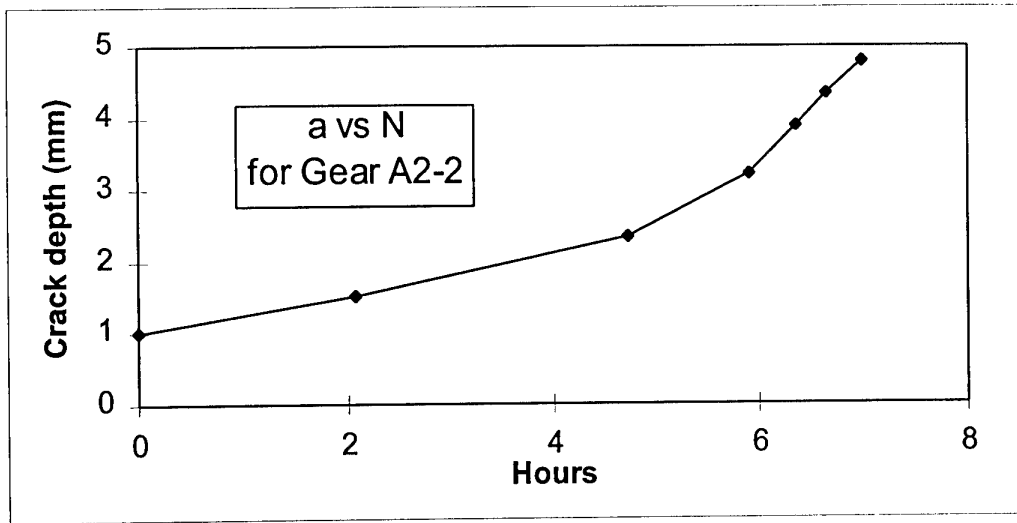
Figure 10.5 Crack growth curve for Gear A2-2

The crack growth curve can be seen in Figure 10.5. As with the curve for Gear A2-1, the trend is as expected. The log-linear curve is shown in Figure 10.6.

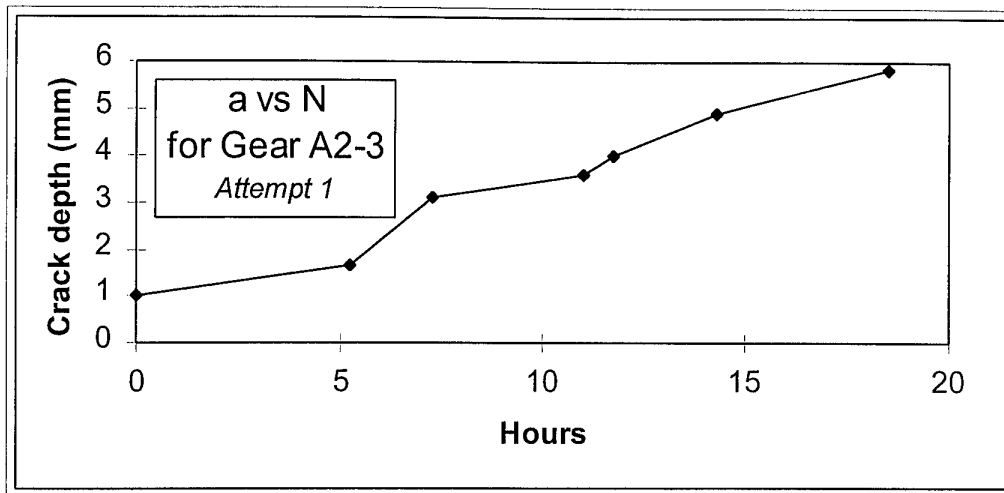
Figure 10.8 Crack growth curve for Gear A2-3 (First Attempt)

Two marks were observed between mark C and the end of the crack (marks E and F). These were related to the first increase of load to 10kW occurring at the start of the third run, and to the middle of the third run where the rig was shut down. This produced the crack growth curve as indicated by Figure 10.8 and the corresponding log linear curve shown in Figure 10.9. As can be seen, these gave curves of increasing crack depth with time, however the trend was not as smooth as the curves obtained for the earlier gears. The first two points seemed to be inconsistent with earlier results.

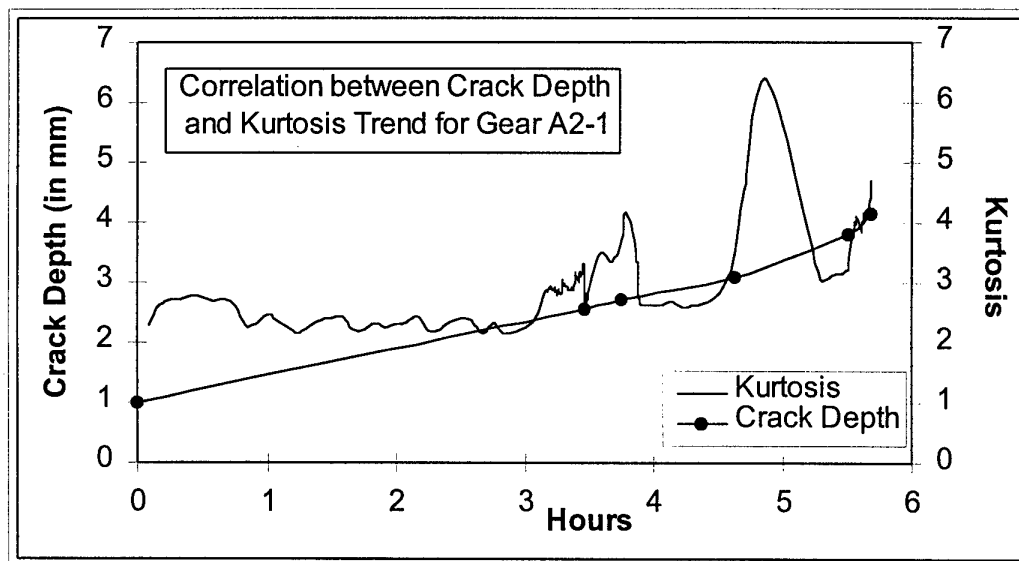
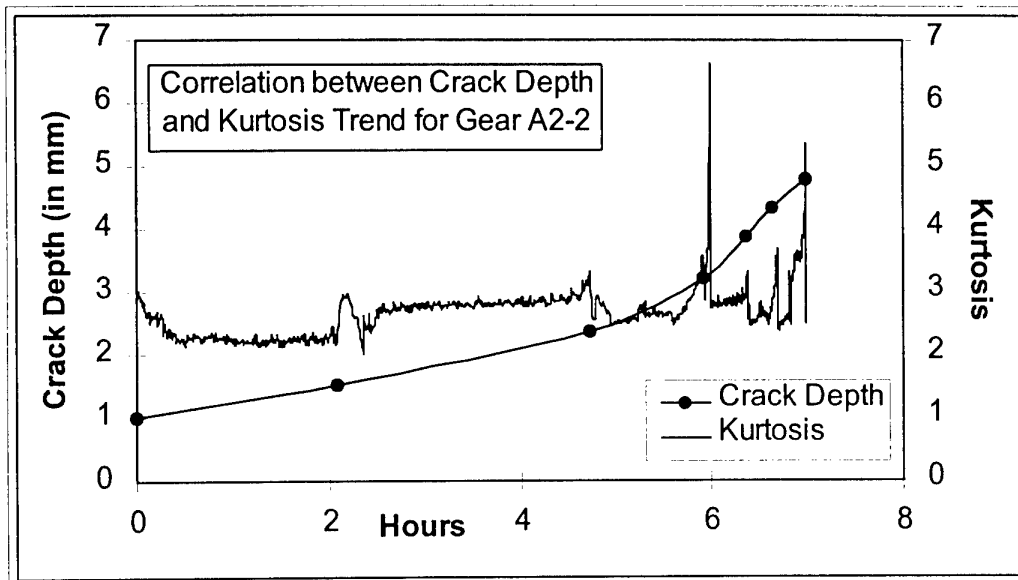
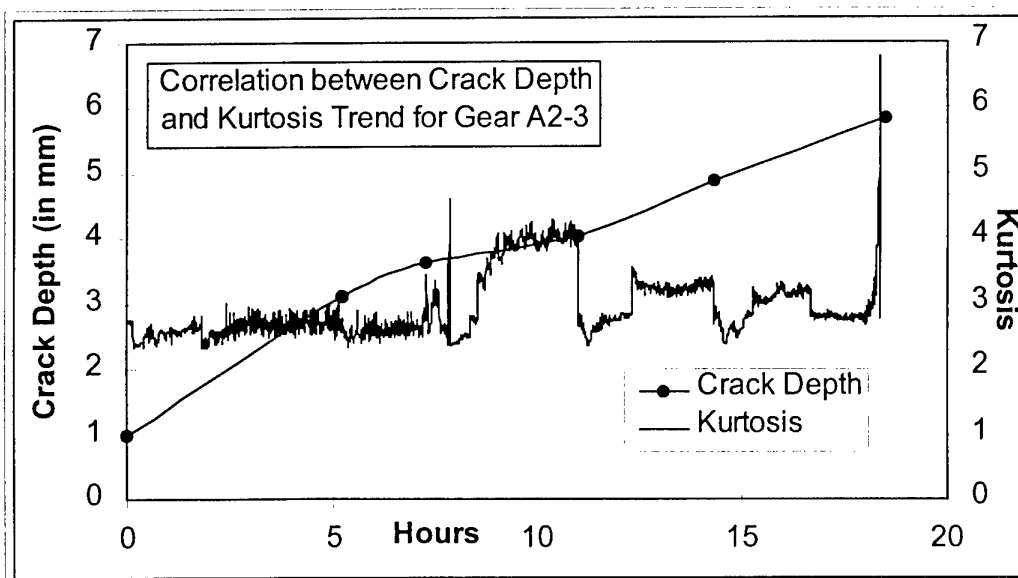
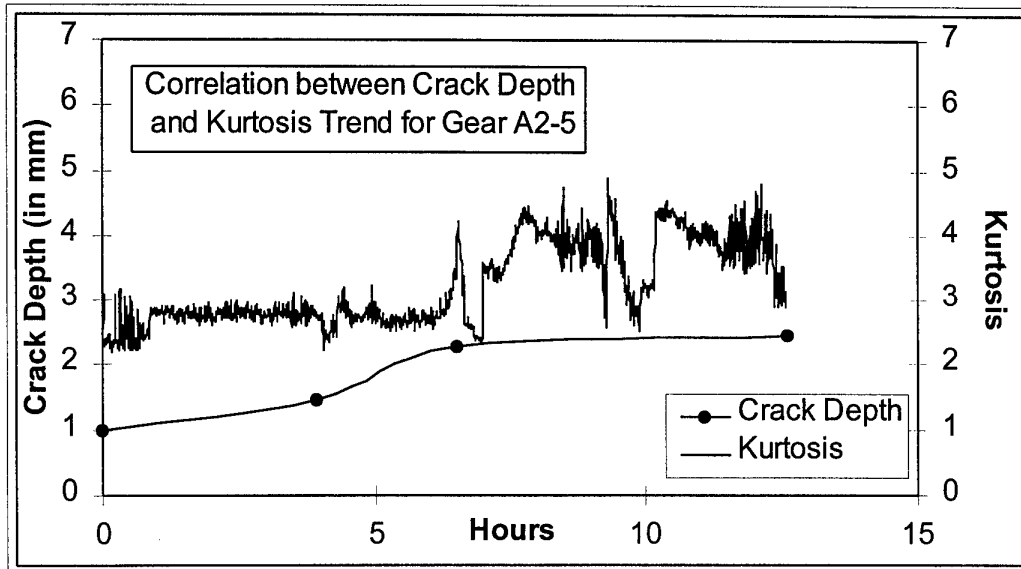
Figures 11.1 to 11.4 show the trend of the kurtosis superimposed onto the crack growth curves obtained for the four gears. As can be seen, the kurtosis does not have that exponential increase that the crack growth exhibits. Interpretation of the two curves is difficult because the values fluctuate with the termination of runs. Based on these curves however, it is evident that the kurtosis can provide an indication of the presence of the crack, but gives no clear correlation with the progression of the crack over each stage of its life. Therefore it does not appear to be a good indicator of the actual crack growth characteristics of the gear.
